A Review of Cavitation in the Cooling Fluid of an IC Diesel Engine Due to Forces Generated in the Piston Cylinder Assembly

Keywords: Cavitation, Cooling fluid, Internal Combustion, Diesel Engine, Ansys, Vibrations.

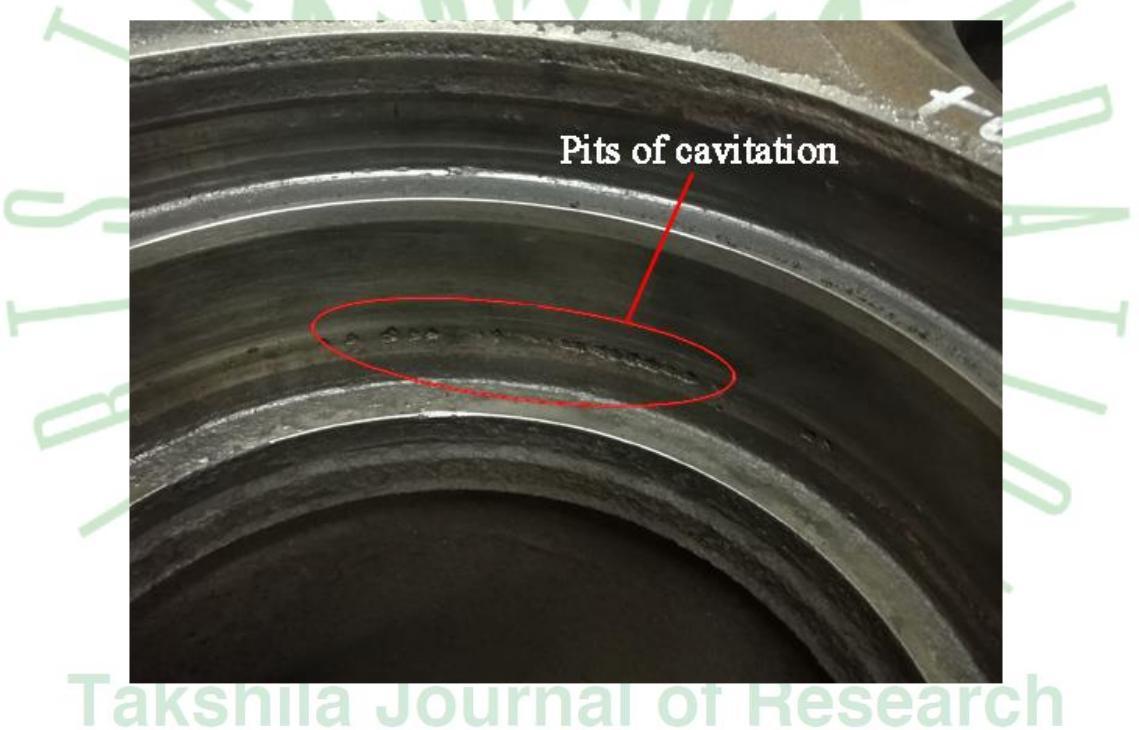
Figure 1. Cavitation of exhaust valve seat

Exhaust valve seat cavitation primarily manifests itself as the formation of needle-like holes on the back surface of the seat, in contact with the coolant. As gas dissolves in the coolant, when high-frequency vibration of the cylinder liner reduces the local coolant pressure to a critical value, the dissolved gas separates into bubbles, which flow toward the high-pressure zone. Collapse occurs when the pressure exceeds the bubble pressure. The bubbled gas redissolves in the coolant, and its volume suddenly decreases. The coolant moves toward the center of the bubble at high speed, producing a water hammer that generates a high impact force and high temperature, propagating at supersonic speeds in the form of pressure waves. When it acts on the exhaust valve seat, it produces high impact, compression, and high temperature. Under the repeated action of this force, the valve seat surface fatigues and gradually crumbles, presenting pits and pores, and gradually expanding as cavitation progresses. Factors affecting exhaust valve seat cavitation in diesel engine cooling water system include: cooling water temperature, cooling method, cooling water cavity structure and arrangement, and cooling water cavitation corrosion, etc., but the degree of influence is not the same.

Cavitation corrosion is characterized by clean surfaces on the valve seats and red pitting, common in internal combustion engines with closed-cycle freshwater-cooled systems. This corrosion is caused by cyclical pressure changes and high-frequency vibrations in the cylinder.

As the cooling water is compressed, the bubbles also compress. The water vapor present in the bubbles rapidly liquefies, and they burst. The surrounding water quickly disperses, generating a strong shock wave that acts on the surface of the valve seats. Although this impact force is small in time and space, it is generated continuously and repeatedly, acting on a very small area of the valve seat, causing plastic deformation and fatigue damage to the metal, which gradually decomposes, forming a hole. This cavitation corrosion develops slowly.
